Piseco Lake Association – 2017 Annual Meeting

**Engineering Services –
Pisecto Lake Outlet Dam**

Kevin Ruswick, PE, CFM

August 19, 2017

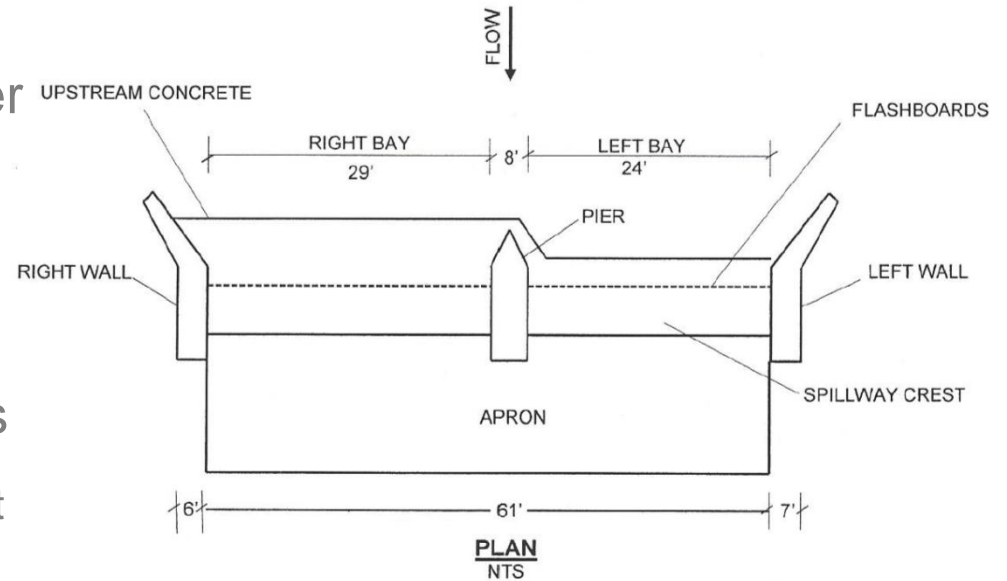
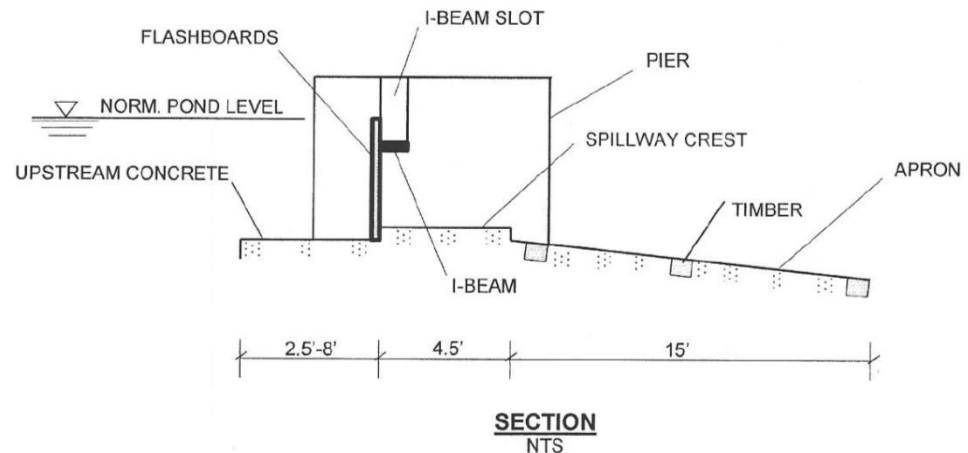
Dam Details (NYSDEC)

- West Branch of Sacandaga River (59.4 sq. mi.)
- Original Construction in 1888 (Timber Crib)
- Dam Modified in 1950's – 1960's
 - Concrete and Earthen Embankment
- 65-ft long, 6-ft max height
- Storage – 164,386 ac-ft
 - Mostly inactive storage
- NYS DEC Class A Structure
- Stop Logs to Manage Lake Levels (May - Oct)

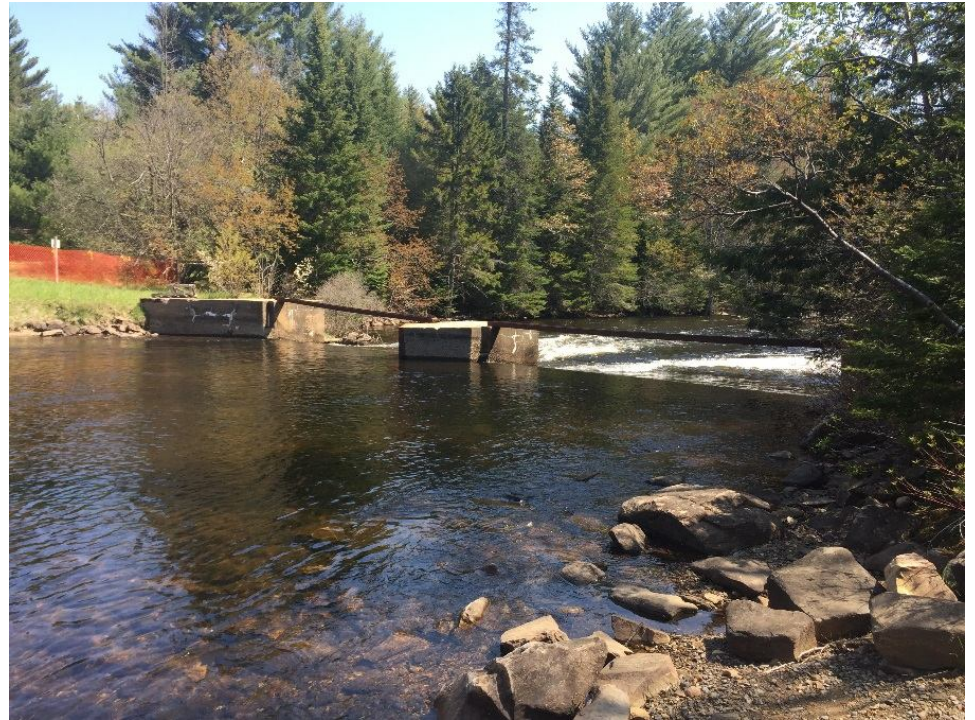
Short-Term Recommendations:

- Remove Trees and Brush
- Repair Undermined Concrete at Left Abutment Wall
- Remove Apron Timbers and Install Engineered Riprap Blanket at Toe
- Armor Left Embankment Abutment
- Repair Leakage Through Left Abutment
- Alternate Flashboard (3-ft, 4-ft) Placement
- Replace Flashboards and Install Walkway
- Install Warning Signs and Fence

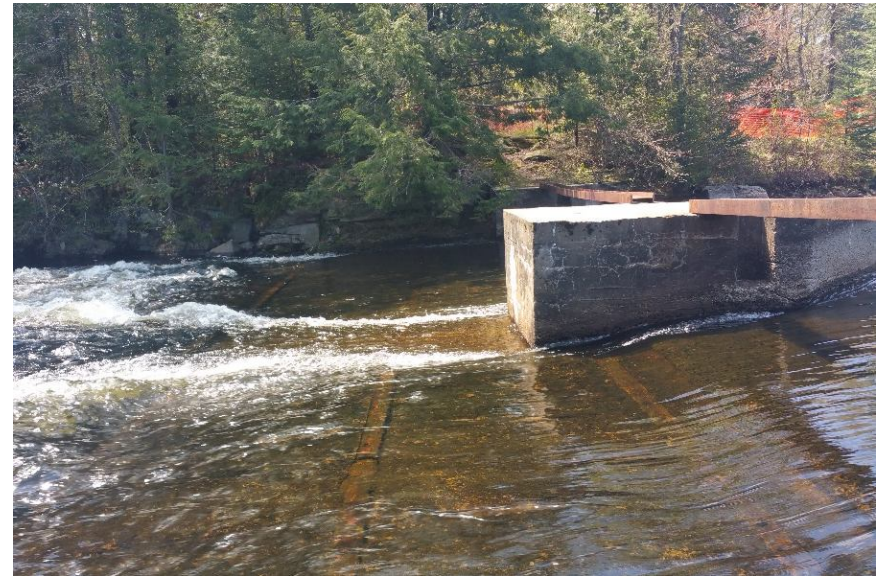
Long-Term Recommendations:

- Topographic and Bathymetric Survey
- Hydrologic and Hydraulic Analysis
- Collect Soil Borings
- Structural Stability Analysis
- Develop Conceptual Design and Cost Estimate
 - Address Dam Safety Deficiencies
 - Consider Automated Flashboards and/or Spillway Gates
 - Spillway Apron Repair
 - Increase Spillway Capacity, Raise/Protect Abutments
- Final Design & Construction

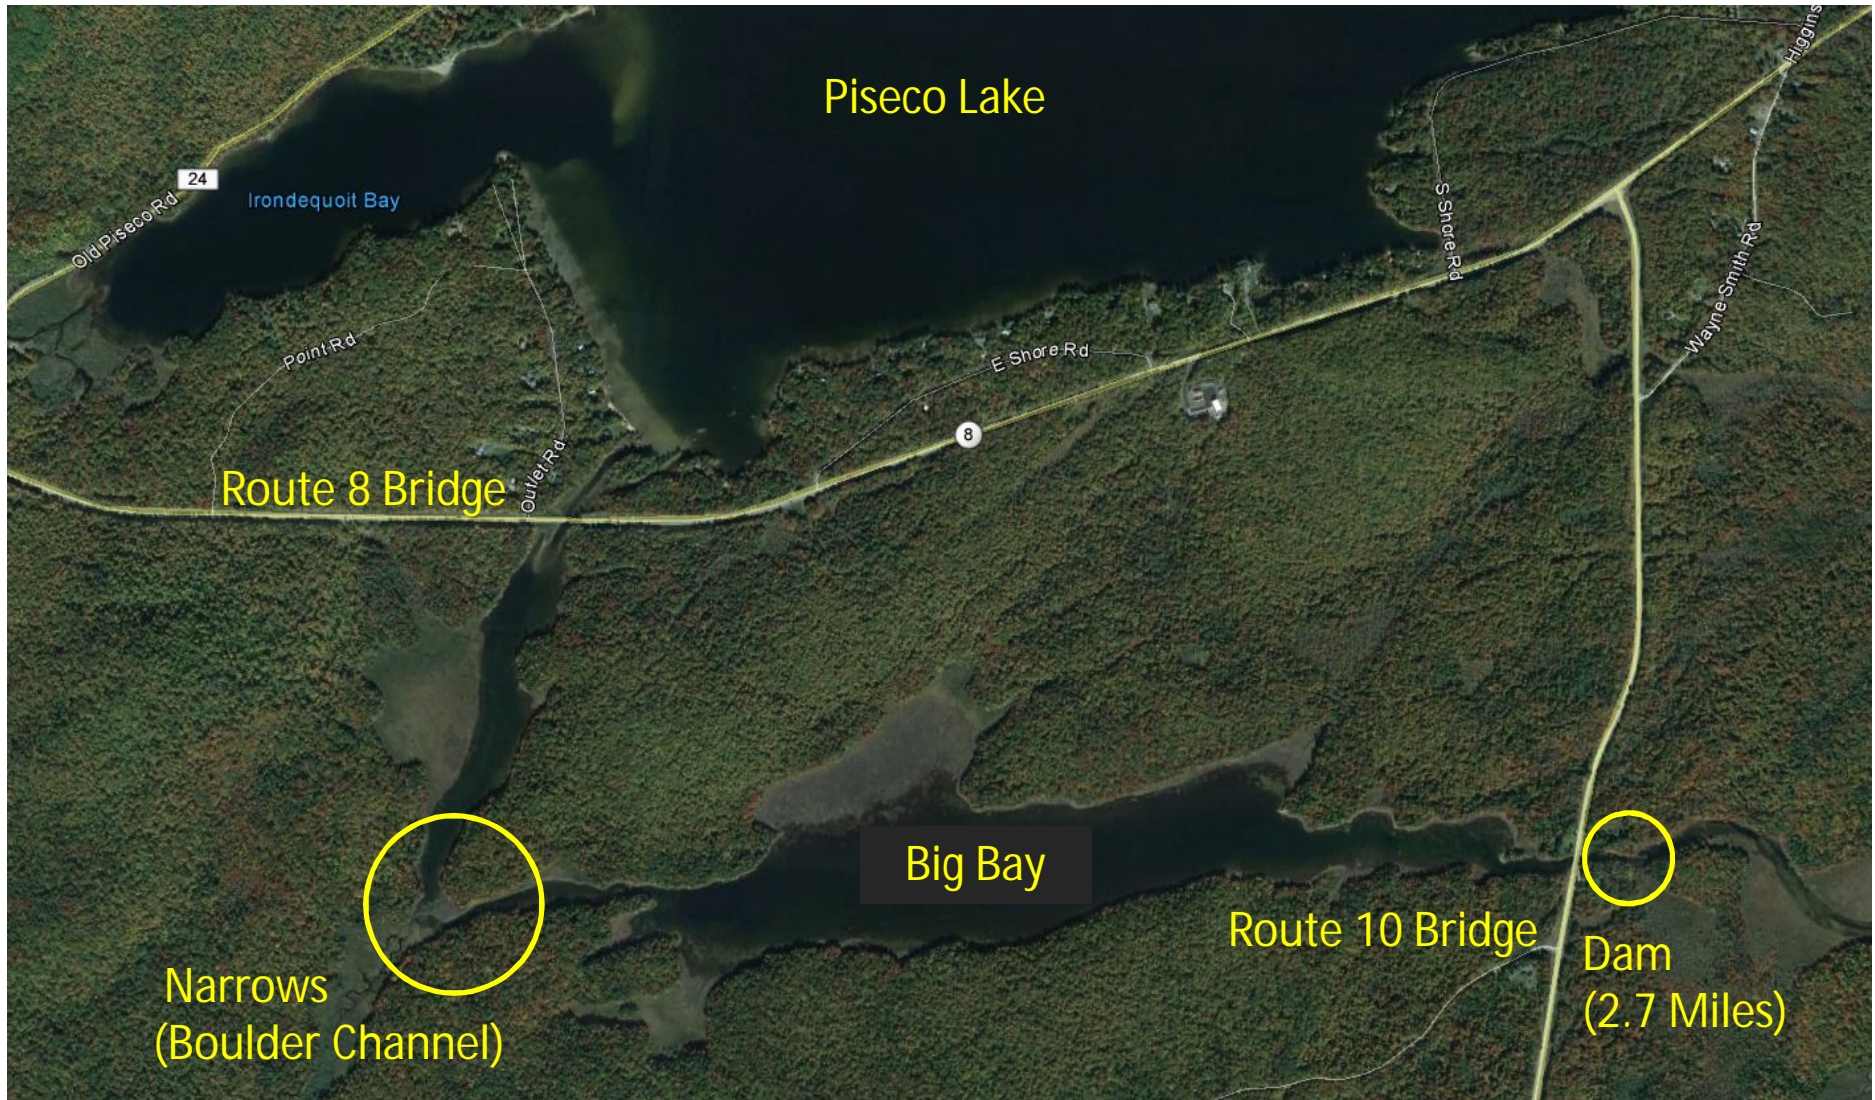
Anecdotal Lake Level Data

Water Level at Piseco Lake
506.1 meters (1660.4 ft)

“The structure only acts as a dam when the ... flashboards are in place,” Fontana wrote in a 1999 letter to Spy Lake Corporation, which owns the property.

The boards raise the water level about three feet above the streambed and the lake level by a foot to 18 inches, he wrote, because the streambed is below lake level.

Water Level at Rt 10 Bridge
504.3 meters (1654.5 ft)

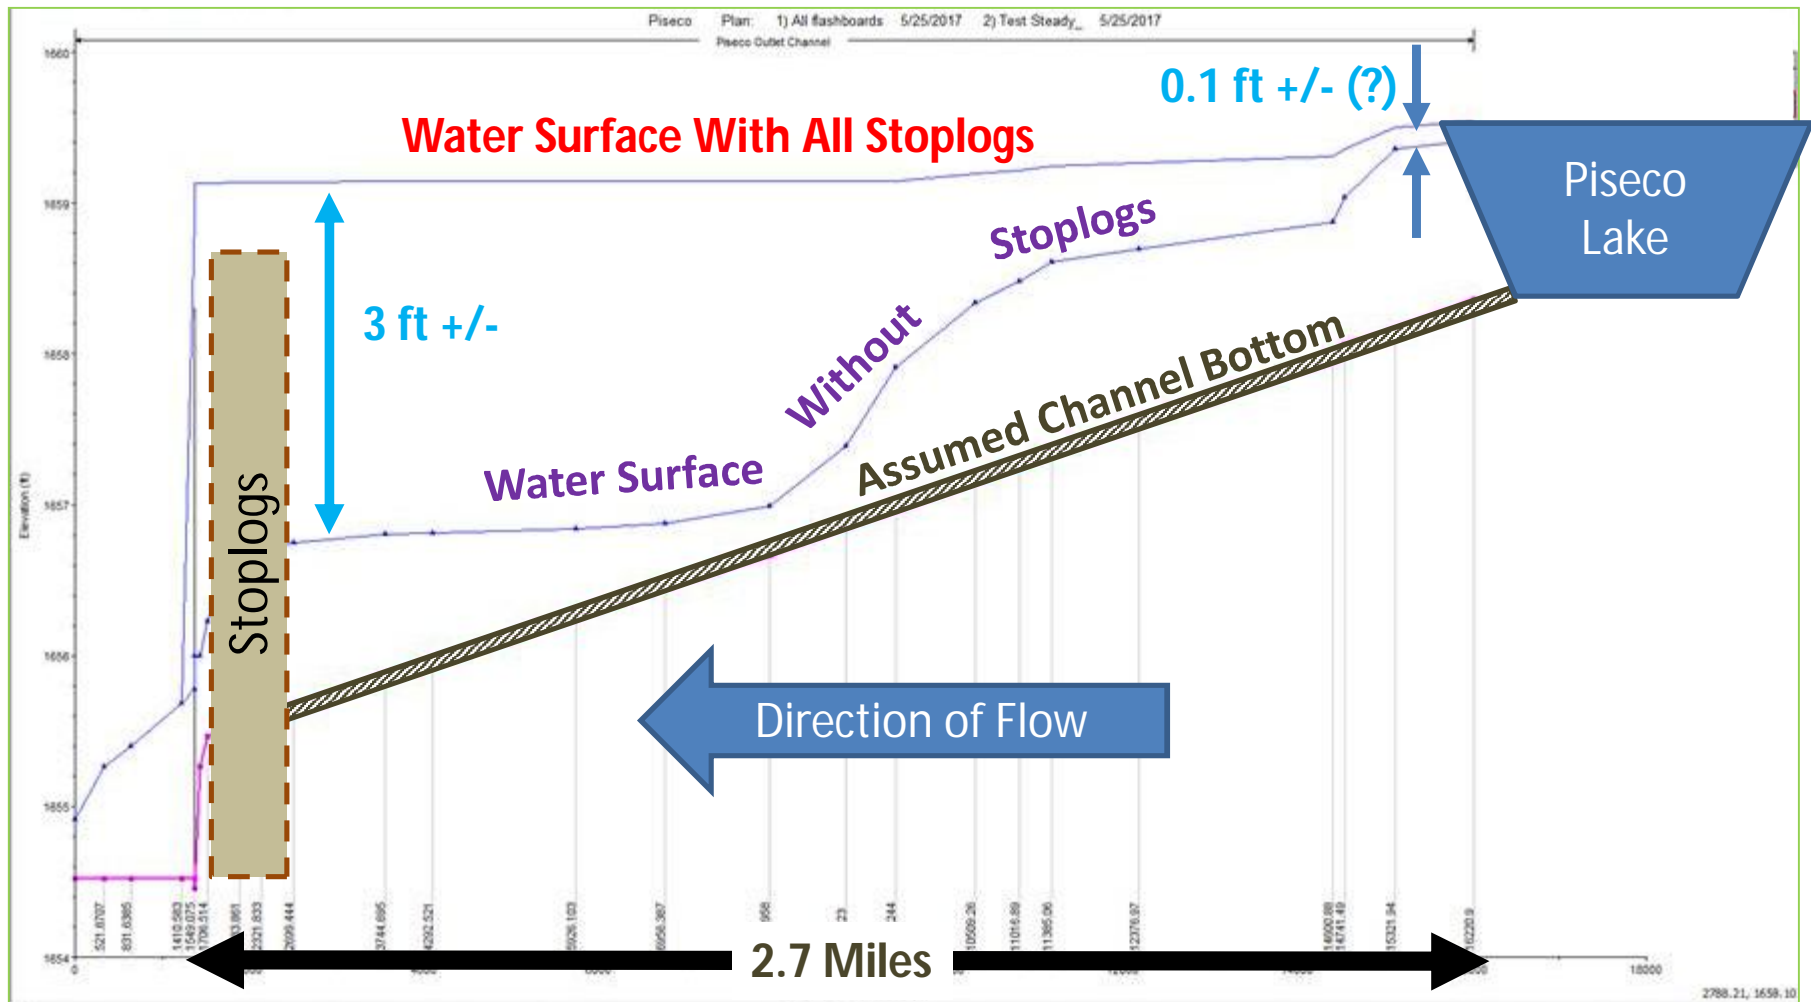
Preliminary Hydraulic Model Results

Dam / Route 10

Big Bay

Narrows (Boulder Channel)

Route 8

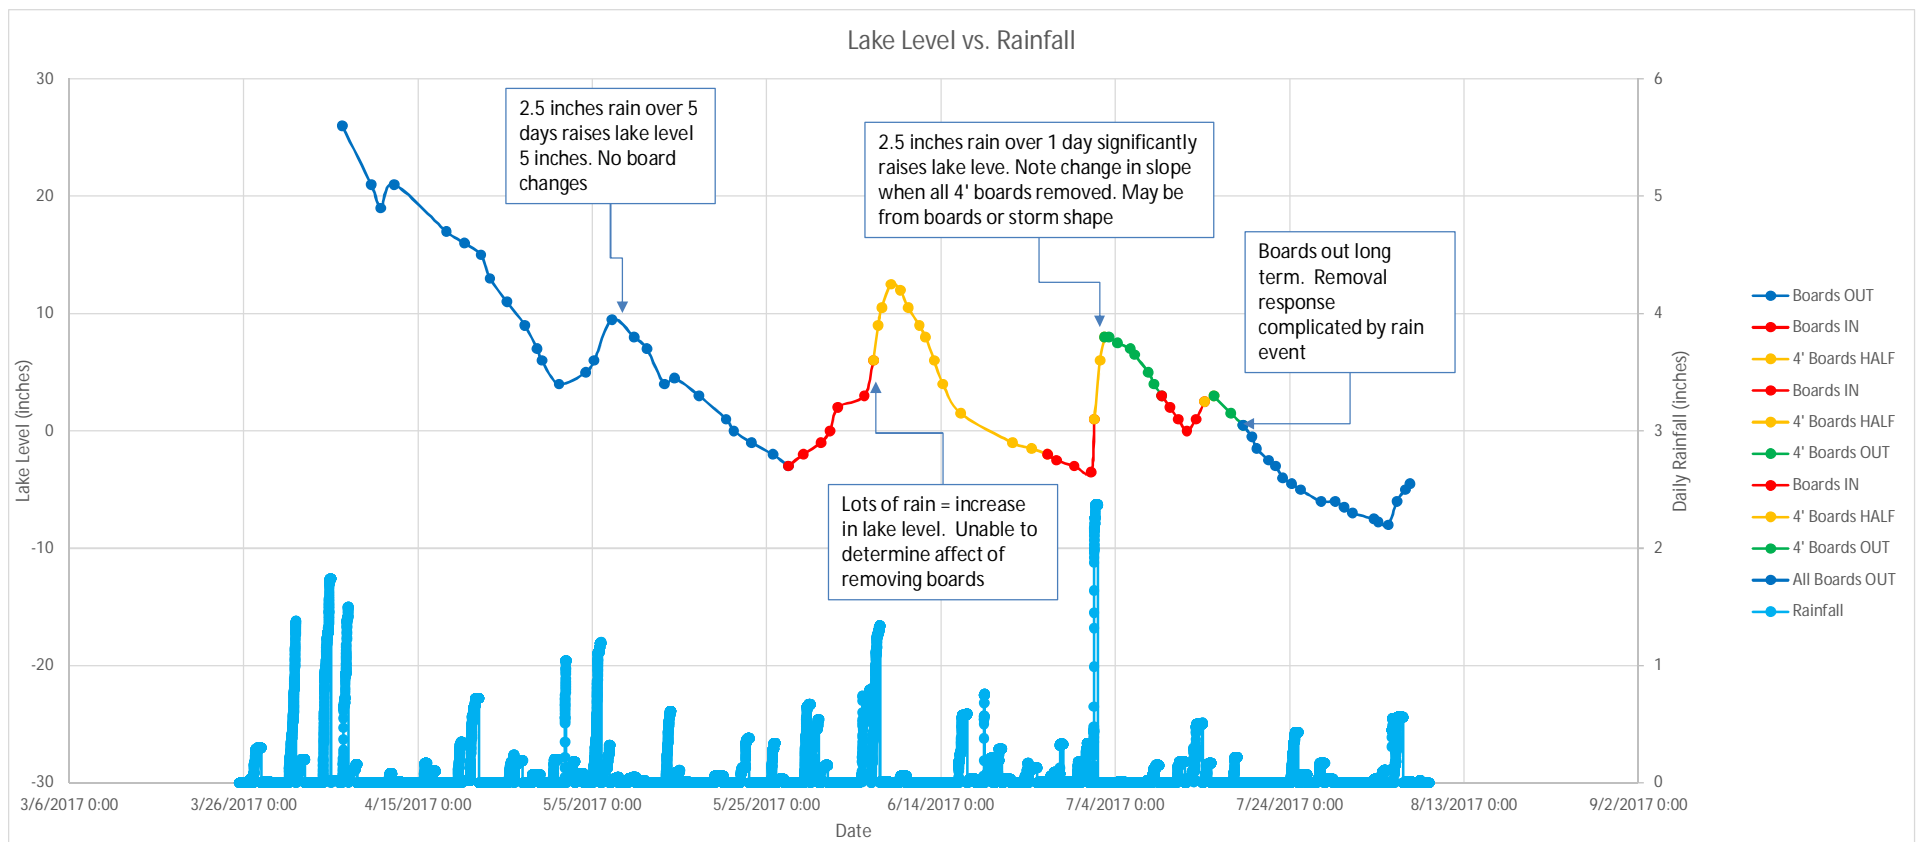
H&H Study Status

- HEC-HMS Hydrologic model developed
 - Waiting for Survey Data to Finalize outflow rating curve & storage rating curve
- Hydraulic Model – Waiting for Survey Data
- 2017 Lake Level Monitoring - Ongoing

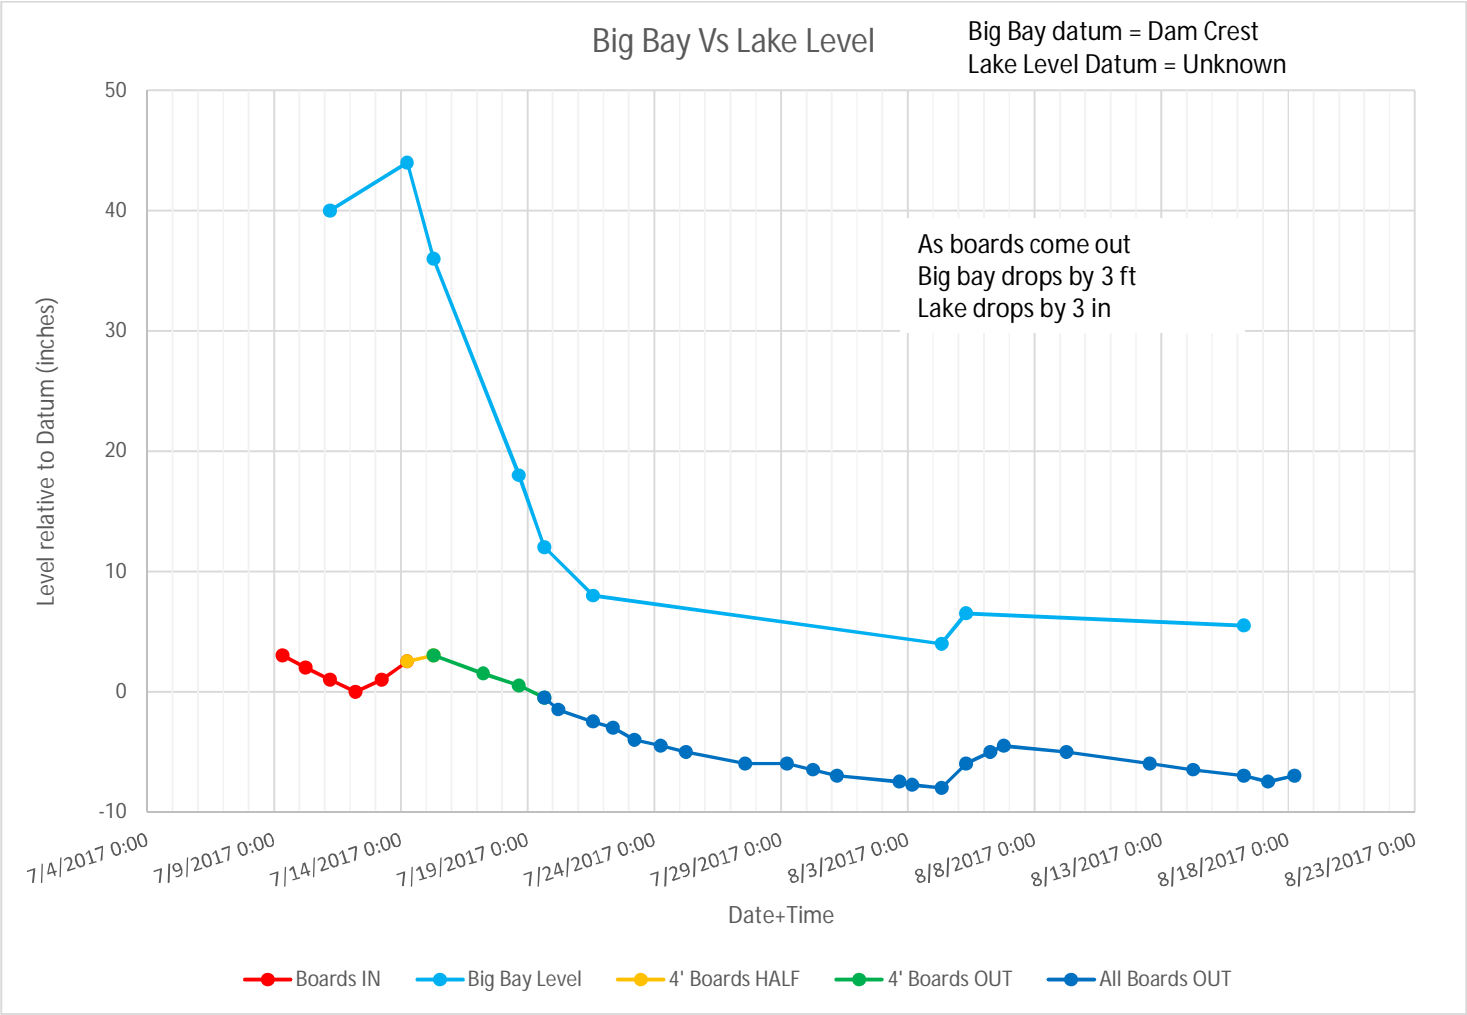
Recent Lake Level Monitoring

■ Lake Level & Big Bay Level

■ Correlate water levels with stop-log operation

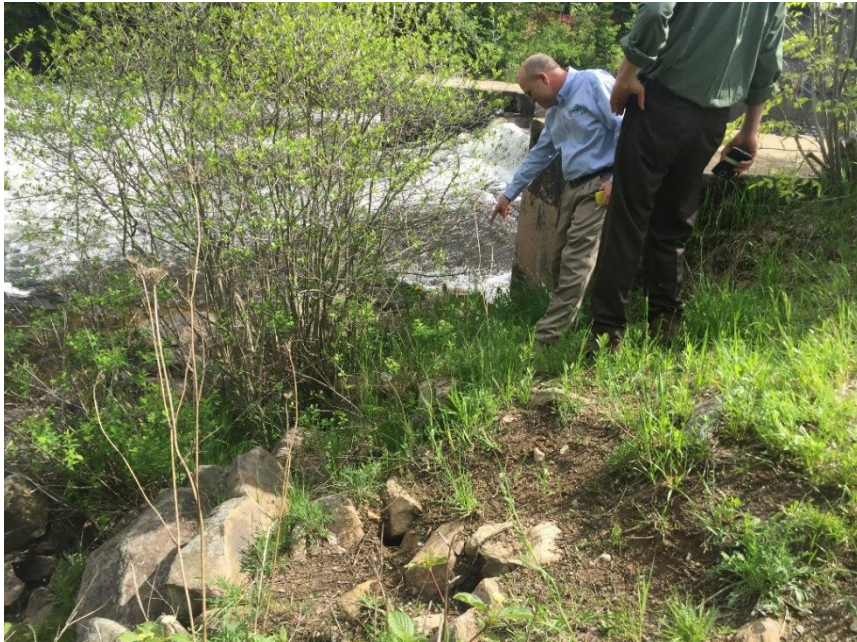
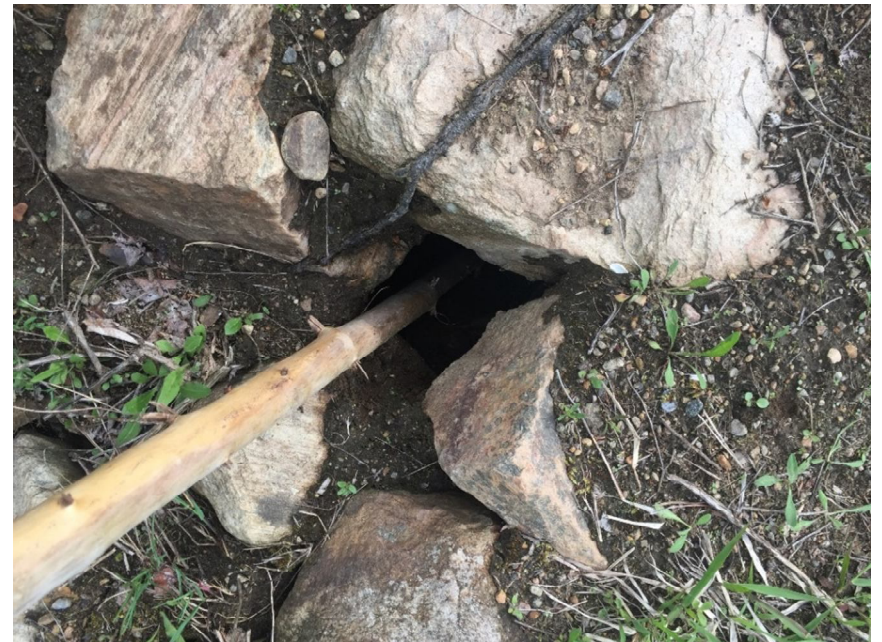
Geotechnical Investigation

- Explore Left Abutment
 - Seepage Assessment and Material Loss
- Town is working on arrangements for excavator
 - Evaluate “unseen” below-grade conditions
- Schnabel is coordinating with local stone suppliers for material availability and specs
- Schnabel will coordinate with NYSDEC – Dam Safety to assess maintenance permitting requirements

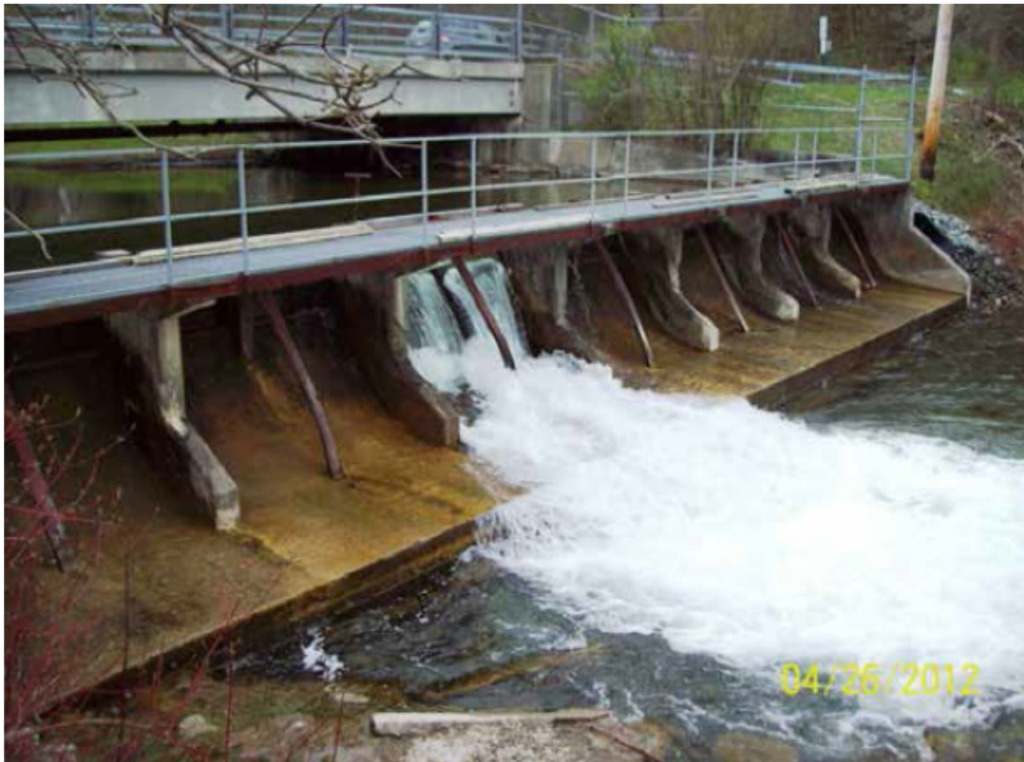
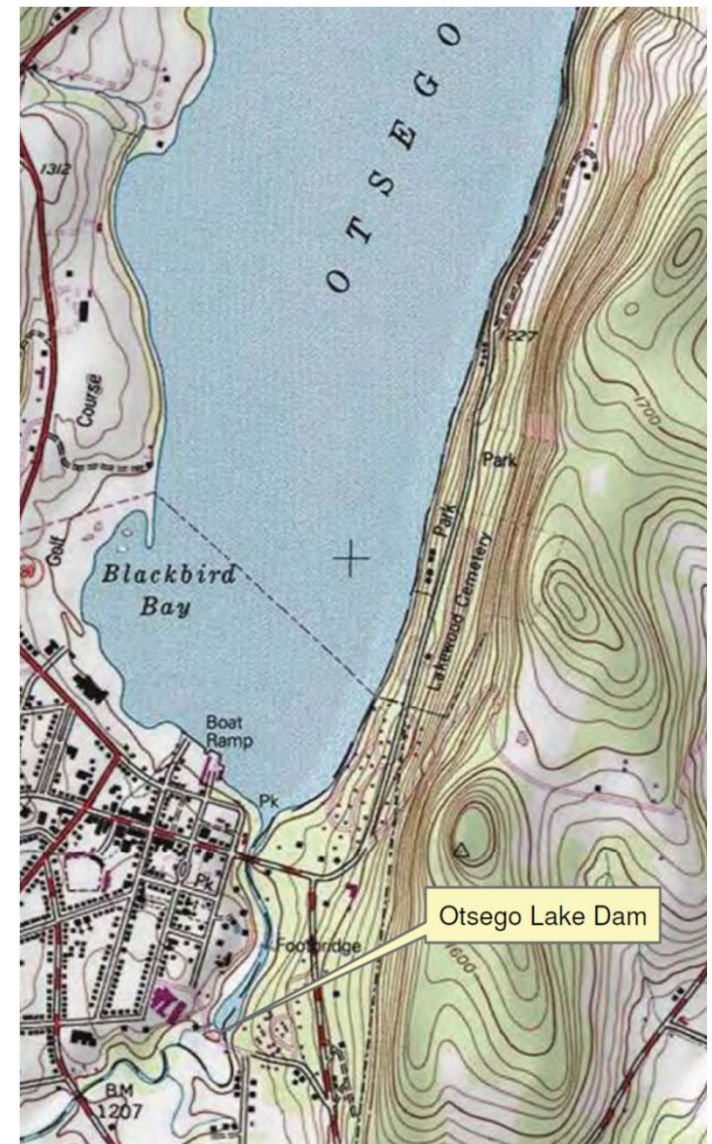
Case Study: Otsego Lake Dam – Cooperstown, NY

- Dam is located approximately 1-mile from Otsego Lake.
- Schnabel performed Hydrology & Hydraulics analyses to evaluate flood reduction alternatives.
- Channel and constrictions between lake and dam limited outflows from lake.
- Schnabel performed hazard class assessment and lowered from Class B to Class A.

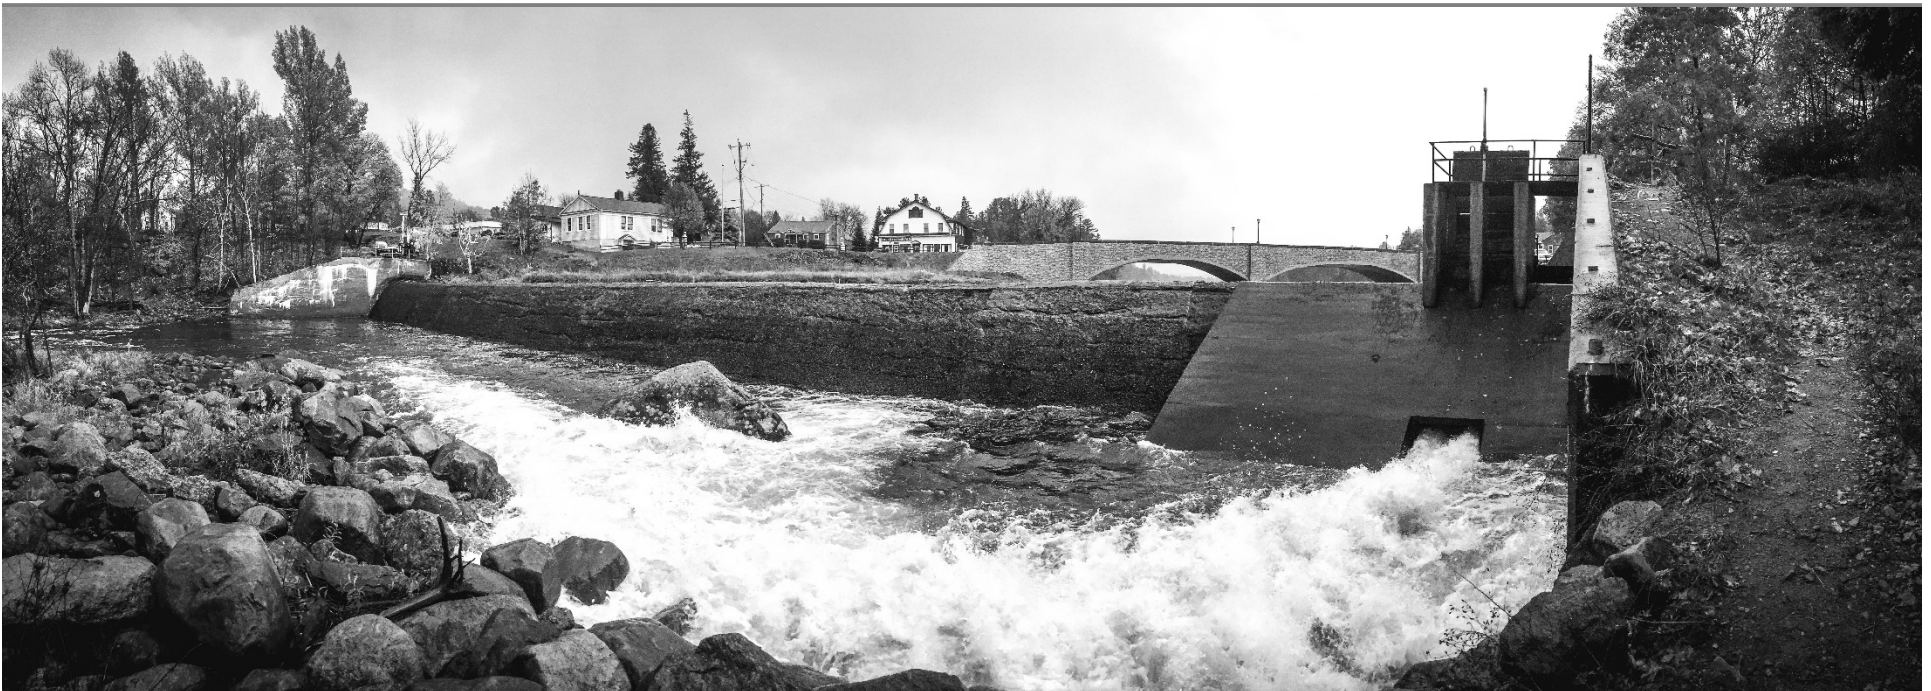
Case Study: Wilmington Dam Operational Improvements

- At Wilmington Dam, the existing outlet gate does not allow much flexibility with respect to installing and removing stop logs.
- We are helping the Town improve operations by designing and installing a new low-level gate.
- We made use of hydrologic and hydraulic models to design a practical and cost-effective solution, which is pending construction.

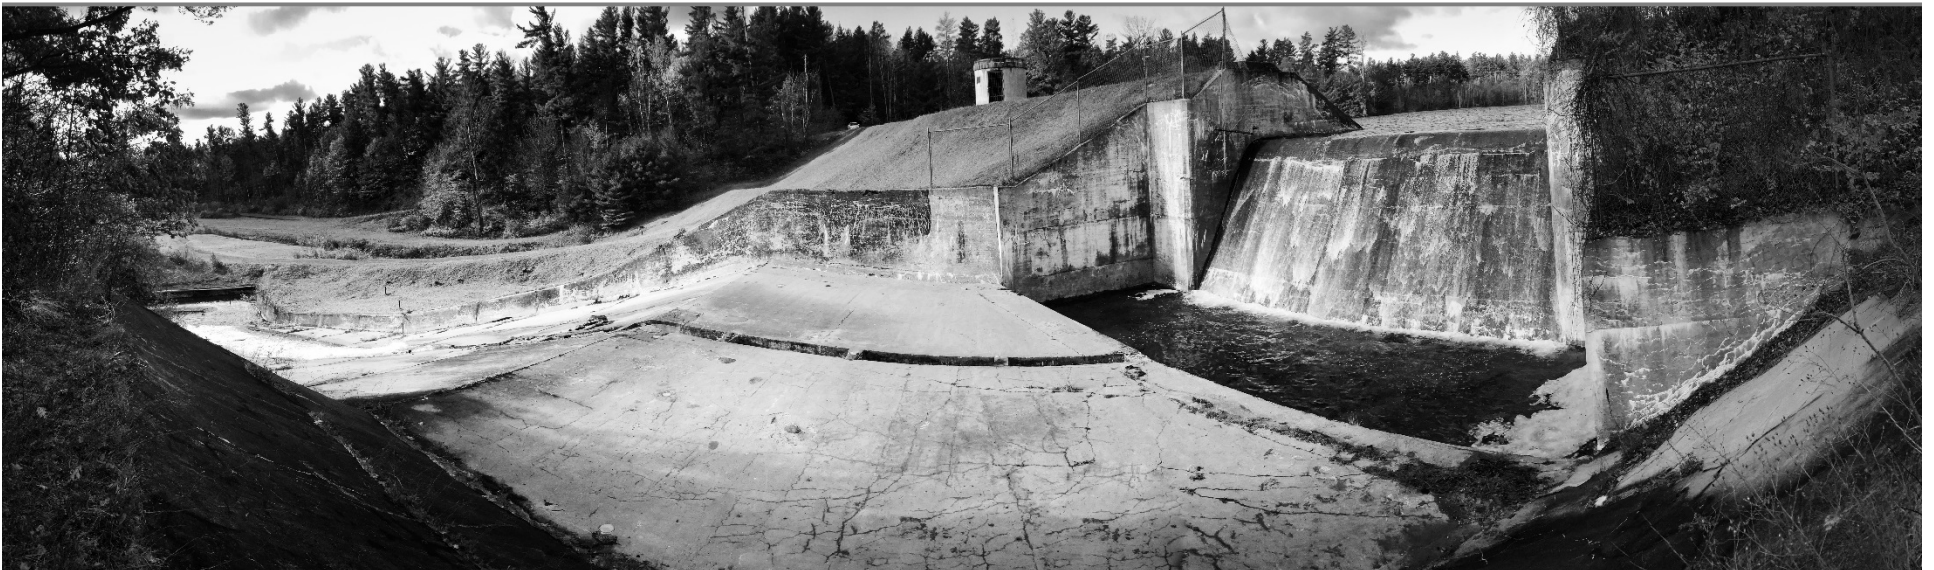
Case Study: Mead Reservoir Dam – Plattsburgh, NY

- At Mead Reservoir Dam we utilized refined hydrologic modeling to reduce (by a factor of two) the spillway design flood which had been developed by another consultant.
- Schnabel's approach was approved by NYS DEC and represents an estimated \$3M in construction cost savings for the City.
- We are currently developing rehabilitation designs for the new spillway.
